**Subject: - VISIT OF THE INSPECTION TEAM REGARDING THE INSPECTION OF THE PROJECTS OF E&SE DEPARTMENT.**

Subject: **INSPECTION REPORT REGARDING SCHEMES UNDER KP-HCIP PROJECT IN DISTRICT PESHAWAR**

Inspection Report in respect of randomly selected schools in District Peshawar.

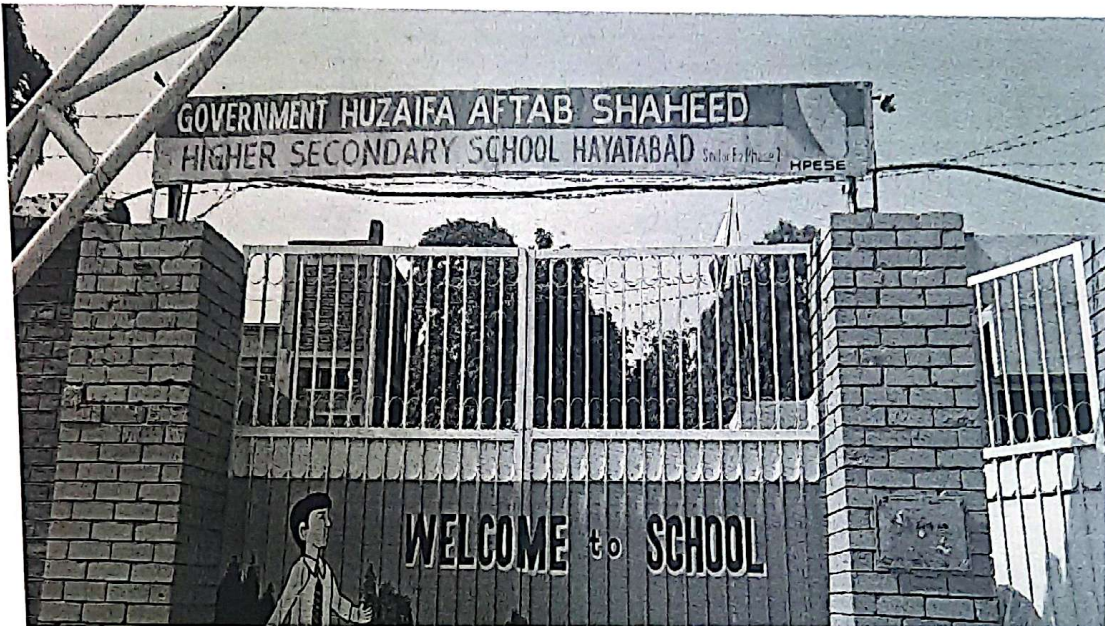
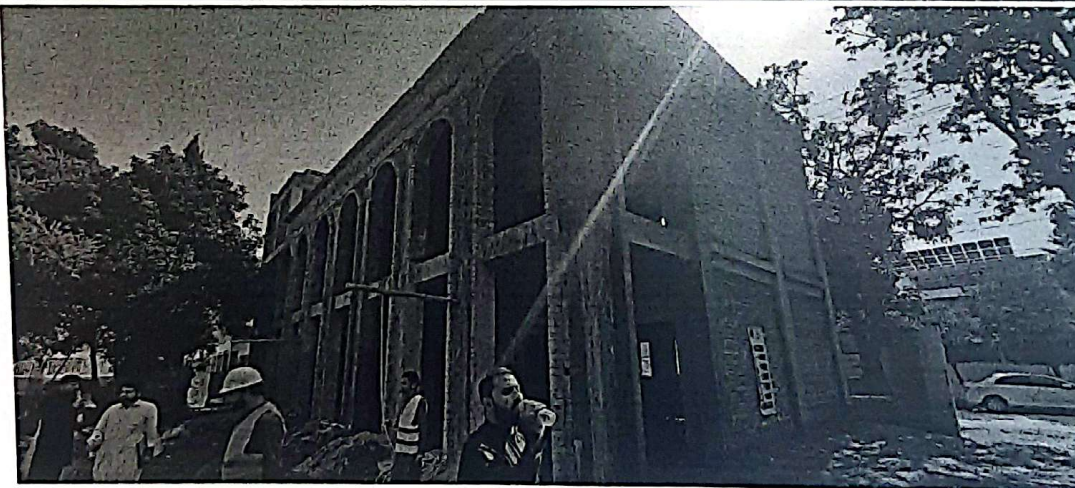
Main building front of GHSS Hayatabad (6-ACR)

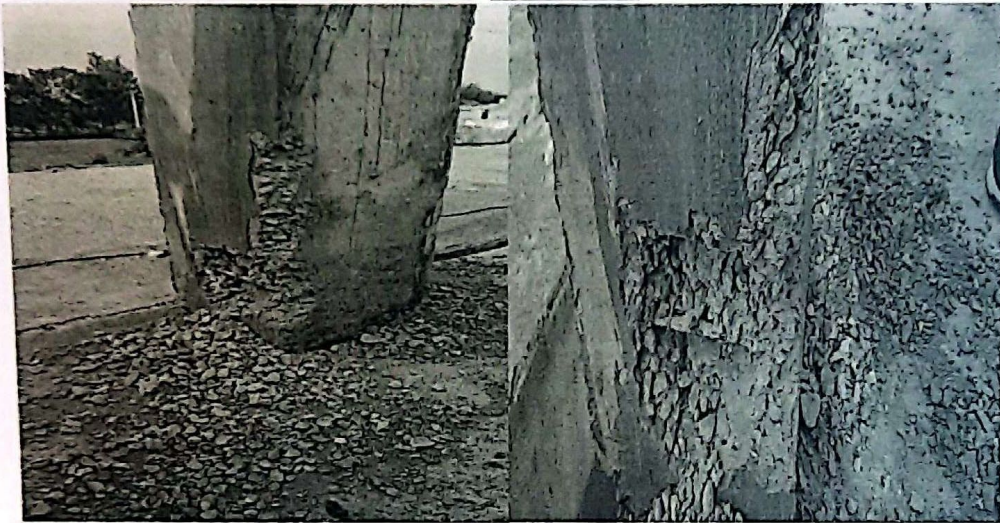
During the inspection of GGPS Ali Mohammad Banda, the quality of Reinforced Cement Concrete (RCC) work was found well below acceptable standards. When RCC columns were lightly hammered, the concrete surface disintegrated and fell off like loose mud, indicating a very weak bond and insufficient cement content.

As per approved design and PC-I specifications, the required mix ratio for structural concrete is 1:1.5:3 (Cement: Sand: Coarse Aggregate). However, the concrete observed at site was found to be significantly leaner and non-compliant with this specified ratio, implying gross deviation from design and contractual requirements.

The observed condition reflects extreme under-strength concrete. Such poor-quality RCC seriously compromises the structural integrity, load-bearing capacity, durability and a potential safety hazard and non-conformance with both PEC Standard Specifications and Clause 9.2 of the Contract Agreement (Quality of Materials and Workmanship).

Extremely Poor Quality of RCC Work (RCC Column) GGPS Ali Mohammad Banda (4ACR)

- I. Immediate core testing or Schmidt hammer tests should be conducted to assess the actual compressive strength of the RCC columns through an independent laboratory OR UET Peshawar.
- II. If test results confirm under-strength concrete, the affected RCC elements must be dismantled and reconstructed using the approved 1:1.5:3 mix ratio, ensuring proper batching, compaction, and curing under consultant supervision.
- III. The Contractor should be issued a Non-Conformance Report (NCR), and payment for RCC work may be withheld until rectification and successful re-testing.

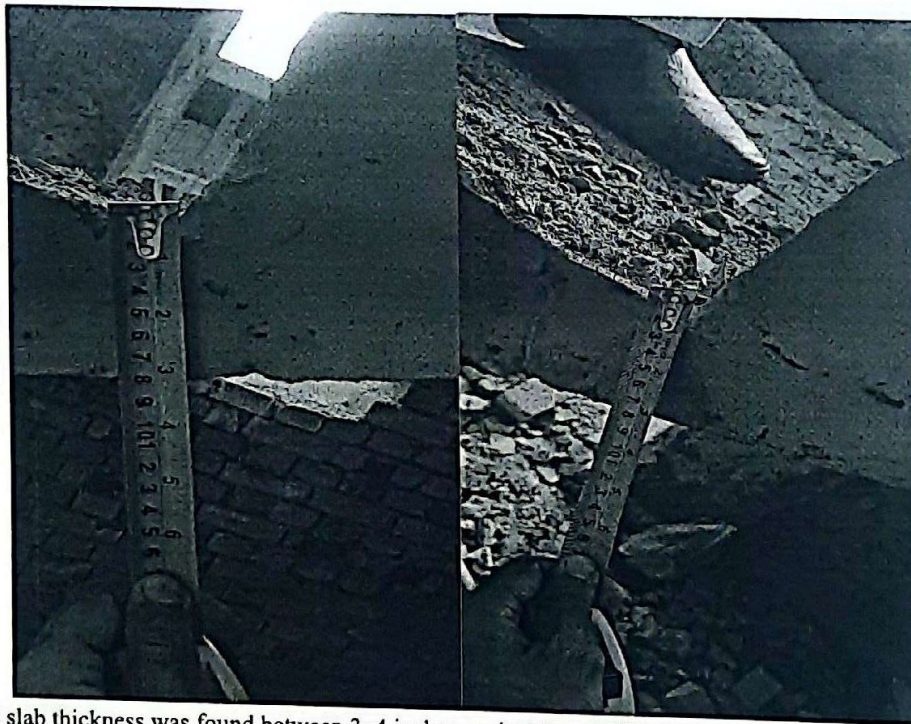
**iii. Deviation in Waste Slab Thickness (Staircase)**

Reduction in thickness compromises load distribution and serviceability, leading to possible cracking and settlement issues.

Waste slab thickness was found between 3-4 inches against the specified 6 inches at several locations

The contractor shall dismantle and re-cast the deficient areas to achieve the specified 6-inch thickness. Future work must strictly adhere to the approved structural drawings and BOQ specifications, verified by site inspection before payment certification.

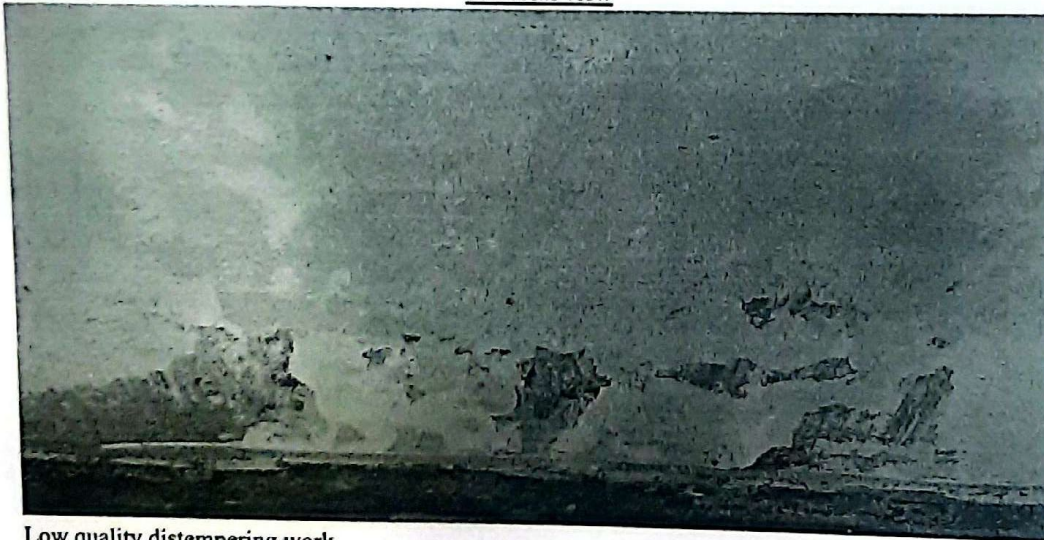
- I. The building's internal walls were distempered without properly scraping the old paint and loose surface layers. Despite this, the contractor has already been paid for surface scraping as per the BOQ item.
- II. Internal wiring was observed to be of inferior quality and not conforming to approved specifications. Notably, 3/29-gauge wire was used for power plugs, which is unsafe and below the minimum standard (expected 7/29 or 7/36) required for socket outlets. The wiring was also found cut at short distances and improperly jointed without junction boxes or proper insulation.

Low quality distempering work

- I. The distemper work shall be re-executed after complete scraping and cleaning of existing surfaces. Payment already made for scraping should be recovered or adjusted as per the consultant's verification.
- II. The contractor shall remove and replace all unsafe or substandard wiring with approved copper conductor PVC-insulated wire, properly jointed and tested for insulation resistance.
- III. False ceiling tiles should be replaced with first-quality, same-color 2×2 ceiling panels meeting the approved brand and specifications. Proper alignment, level, and uniformity should be ensured under the consultant's supervision.

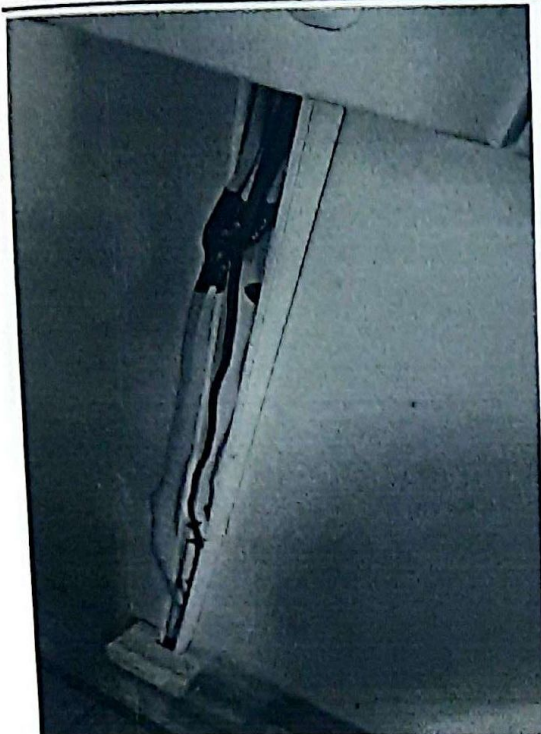
- Inadequate surface preparation before distempering will lead to peeling, uneven finish, and reduced paint life.
- Use of under-gauge and poorly jointed electrical wiring poses a serious fire and safety risk, violating Pakistan Electrical Code (PEC Part-II) and standard electrical safety practices.
- Poor ceiling materials and inconsistent color result in aesthetic deficiencies, reduced acoustic performance, and early material degradation.

Use of under-gauge and poorly jointed electrical wiring

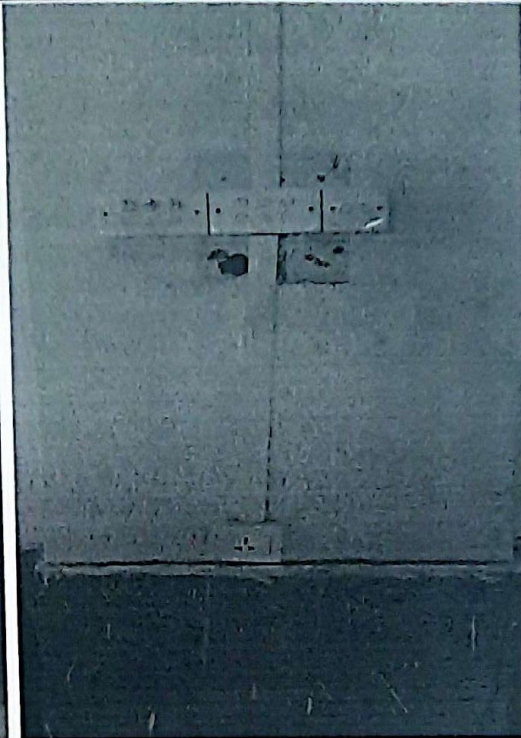
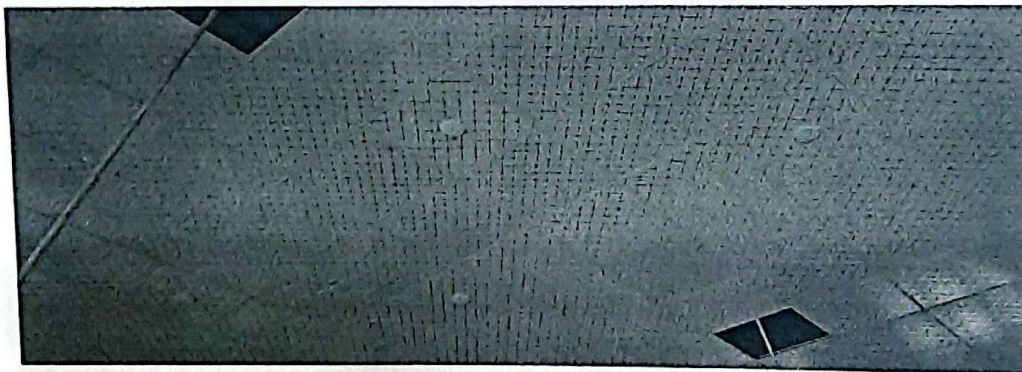
- III. The false ceiling work was found of poor workmanship, made with low-quality 2×2 ceiling tiles that were non-uniform in color and texture. The installation was uneven and visually inconsistent with approved samples and specifications.

Poor ceiling materials and inconsistent color
